# Impact study report

## **“Development of Community Infrastructure”** Implemented by Atul Foundation

March 2026

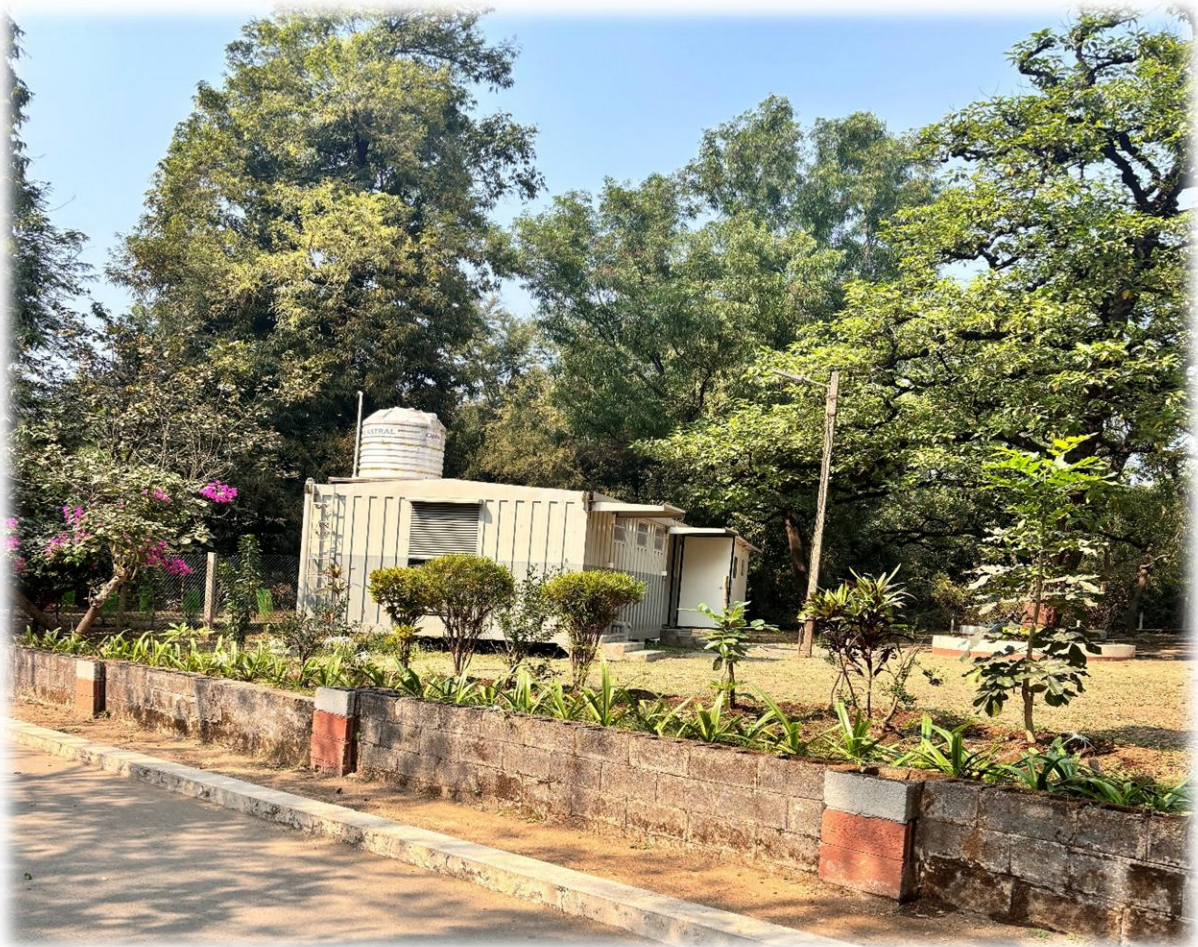
*Figure 1 Portable Toilet*

5 portable toilets (one common and two separate) are constructed for the primary school (two for boys and two for girls) and Balmandir (One porta cabin for 3 to 6 yrs. Kids with staff). Portable toilets are well-maintained, and adequate facilities have been provided. Few operational gaps remain:

- **Hygiene gaps:** Absence of hand soap, inadequate waste management (larger bins required), and need for improved cleaning protocols.

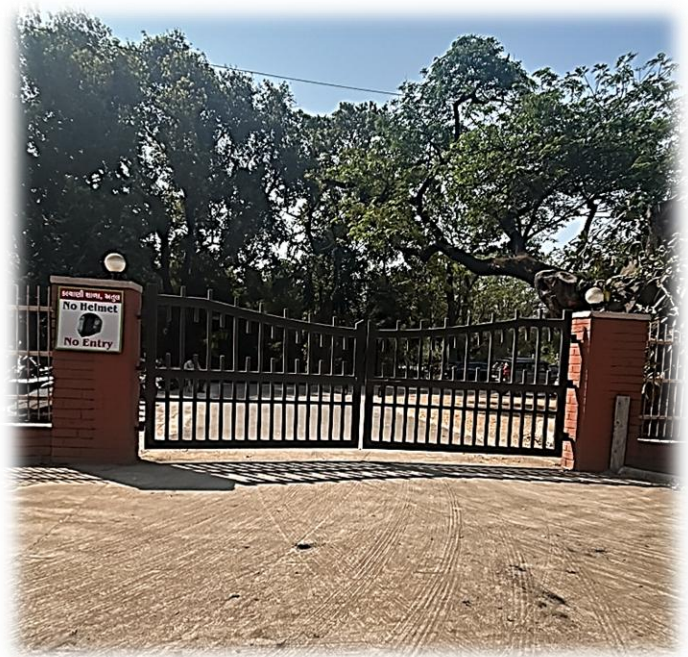
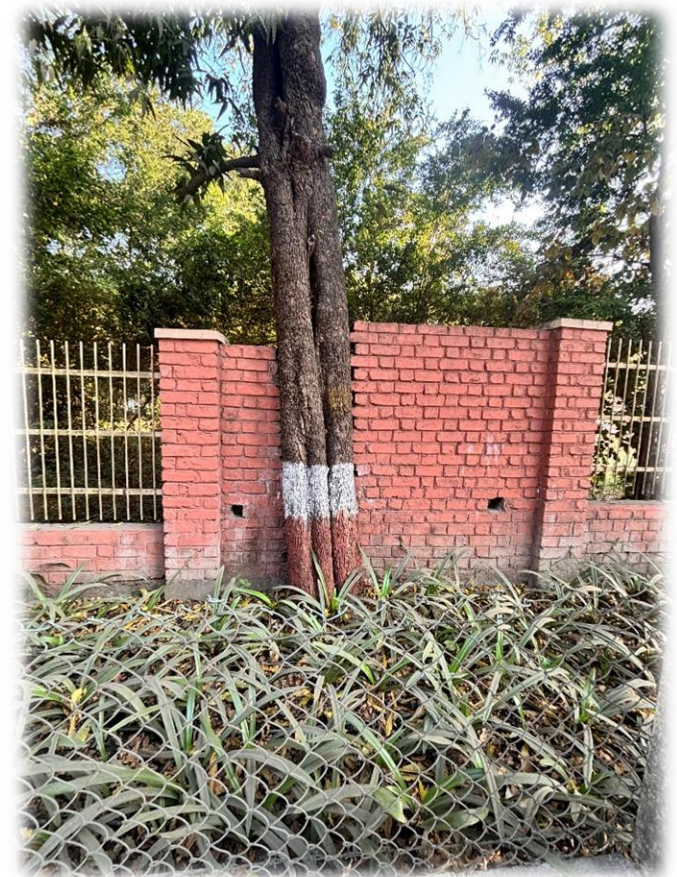
- Wall specifications and Dimensions:
  - Total Length: 2,100 meters (2.1 km).
  - Height: From Ground Level- 2100 mm, From Road Level – 1800 mm
  - Structural Elements:  
Foundation/Structure: RCC pile/column (230 mm) for structural stability.  
Wall Body: Exposed Brick wall (115 mm thickness).  
MS (Mild Steel) painted Jali 3000 mm x 1400 mm has been installed between brick walls.

- Key Findings on Structure:
  - No cracks or settlement observed.
  - No dampness or seepage found.
  - No brick efflorescence visible (minor white spots below trees due to leaf deposits).

- No tree roots damaging the wall; trees preserved at certain points.
  - Expansion joints are provided at approximately every 30 meters.
  - Weep holes provided (currently covered by rubble masonry).

- Three culverts were constructed along the wall.

Overall, the compound wall is structurally sound and well-maintained.
